ข่าวสำนักงาน ป.ป.ช.

NACC Bueng Kan Inspects the Collapse of the Huai Dang Concrete Road in Ban Pong Hai

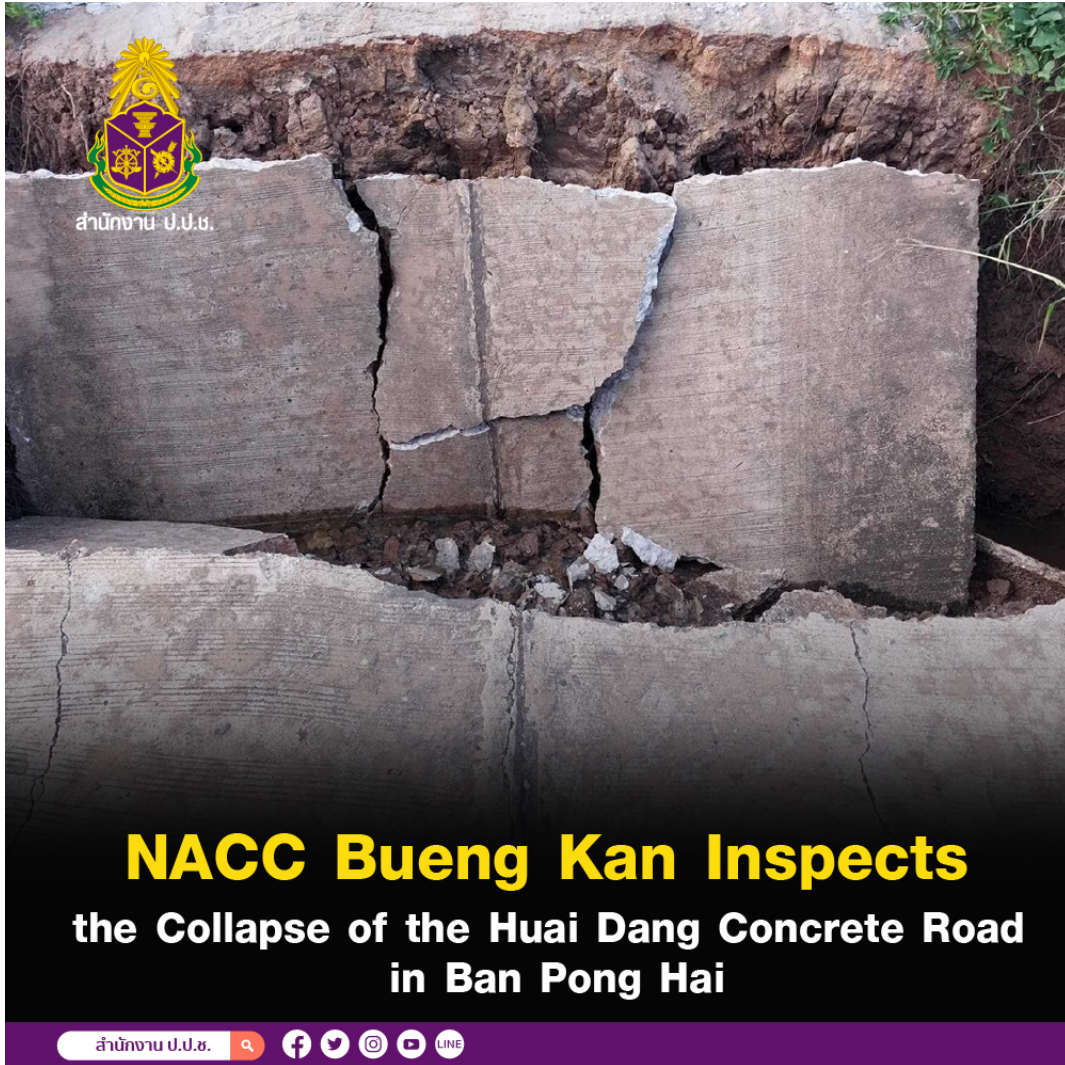
From the field inspection by the NACC provincial office officials, it was confirmed that the construction project was indeed under the jurisdiction of the Pong Hai Sub-district Municipality as reported. The condition of the road resembled a geological disaster, cleaved with deep holes along its course. Upon reviewing the project's contract, the officials found that it involved the approval of the remaining budget from the fiscal year 2019's discretionary grants, amounting to 3.52 million baht for 14 projects, of which this collapsed road was part of a project with a budget of 495,000 baht.

Upon inspection, core sampling of the road at the collapse site was conducted to determine the actual problems. It was found that the concrete road did have a 4-millimeter thick steel reinforcement layer underneath the concrete layer. However, the reinforcement was significantly lower than the surface layer, compromising the construction's adherence to the proper form and standards. On this issue, the NACC office in Bueng Kan Province will request additional documents to carry out a detailed investigation.

Regarding the issue of the road's collapse that has prevented the local population from using it for transportation, reports indicate that the recent period has been the rainy season, with high volumes of rainfall flowing over the road, leading to erosion of the soil layer beneath the road surface and subsequent collapse. The lack of a steel frame to support the structure, combined with the absence of a soil layer to bear the weight of the concrete surface, caused the concrete road to sag and break down in the manner observed.

As an immediate measure, the NACC officials in Bueng Kan Province have recommended to the Pong Hai Sub-district Municipality to expedite the road repair to restore it to condition, with a deadline set for completion within three days, and to conduct a survey of problems of this nature in the project to prevent similar incidents in the future.
